**REMOVAL PROGRAM
AFTER ACTION REPORT
FOR THE
ANGLO ENTERPRISES COMPANY SITE
WEBSTER, WORCESTER COUNTY, MASSACHUSETTS
2 AUGUST 2016 THROUGH 21 APRIL 2017**

Weston Solutions, Inc.
Superfund Technical Assessment and Response Team IV (START)
101 Billerica Avenue, Building 5, Suite 103
North Billerica, Massachusetts 01862

July 2017

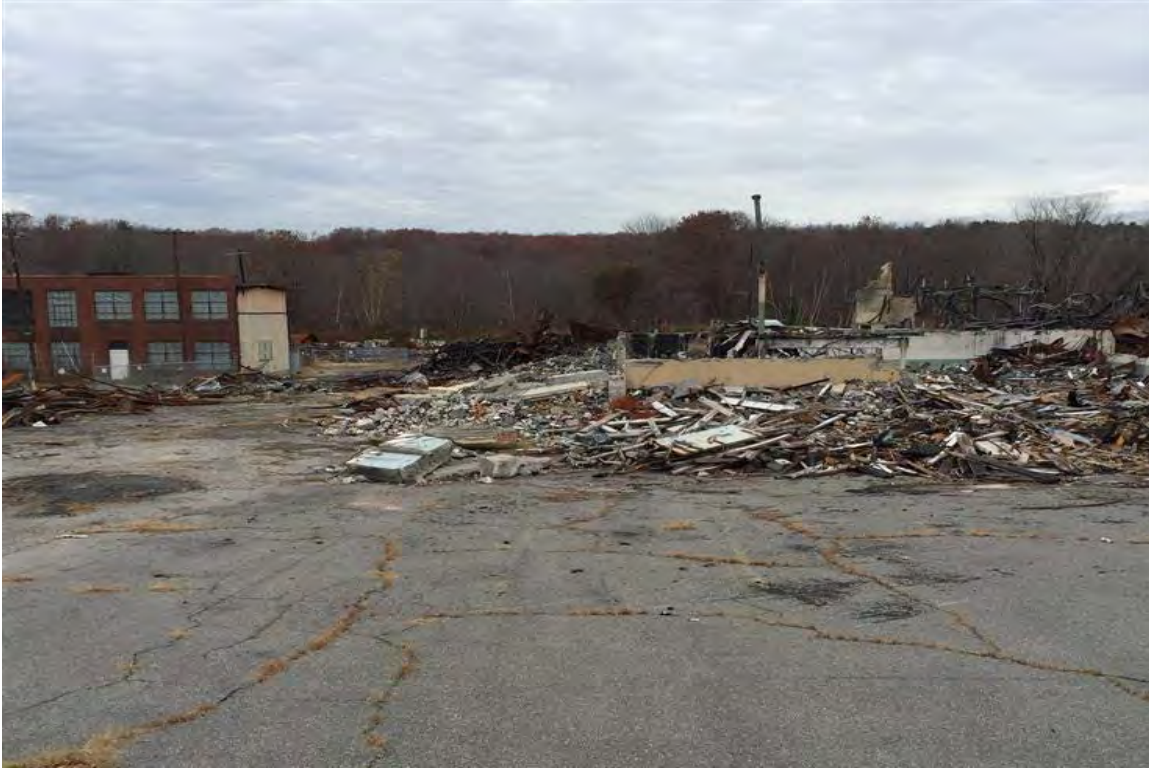
SCENE: View of debris fields along southern fence line and heat-damaged steel structures. Photograph taken facing west.

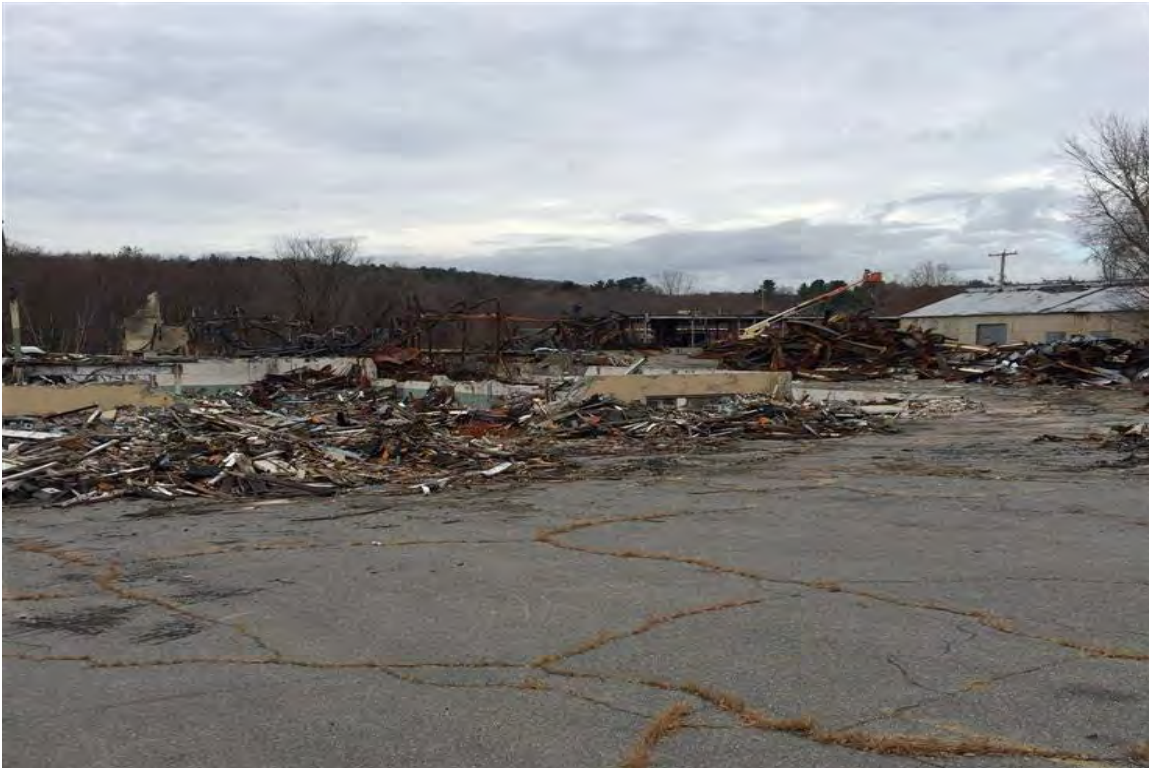
SCENE: View of debris fields along northern fence line, steel piles, and heat-damaged steel structures. Photograph taken facing northwest.

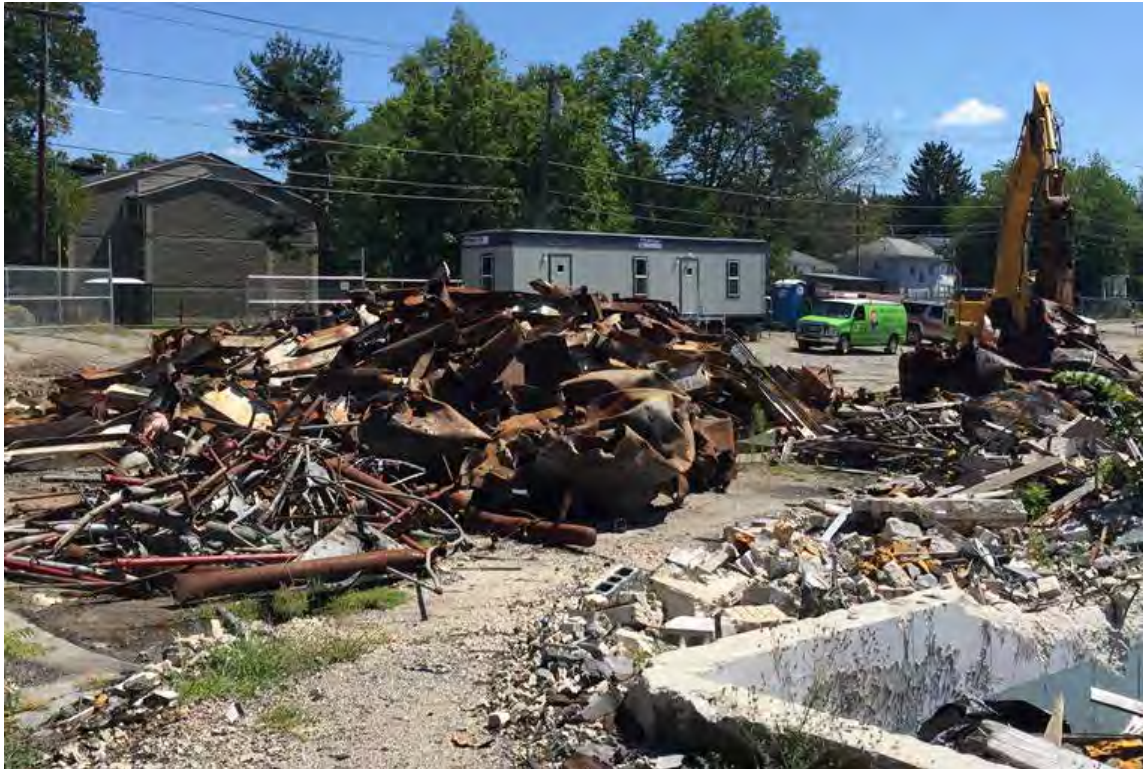
SCENE: View of scrap steel outside the eastern wall of the former Anglo Enterprises building. Photograph taken facing east.

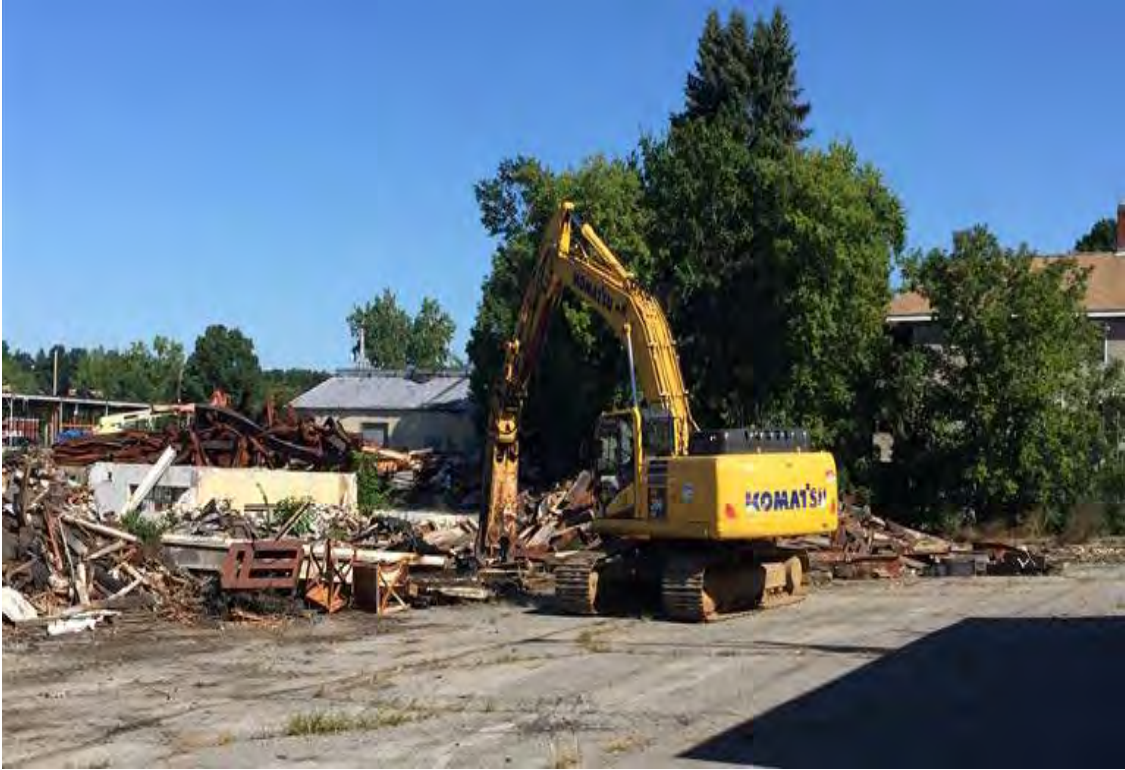
SCENE: View of steel shearing activities outside the eastern wall of the Anglo Enterprises building. Photograph taken facing northwest.

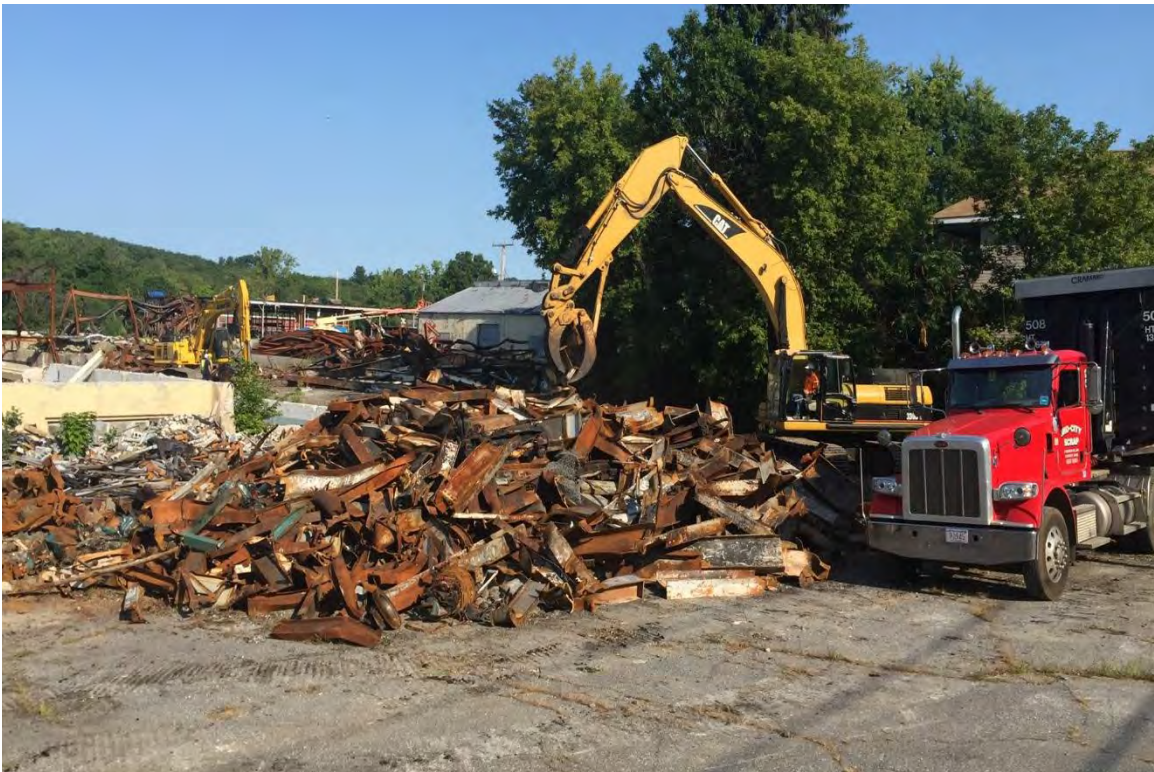
SCENE: View of steel shearing (rear) and steel load out on the northeastern side of the site. Photograph taken facing northwest.

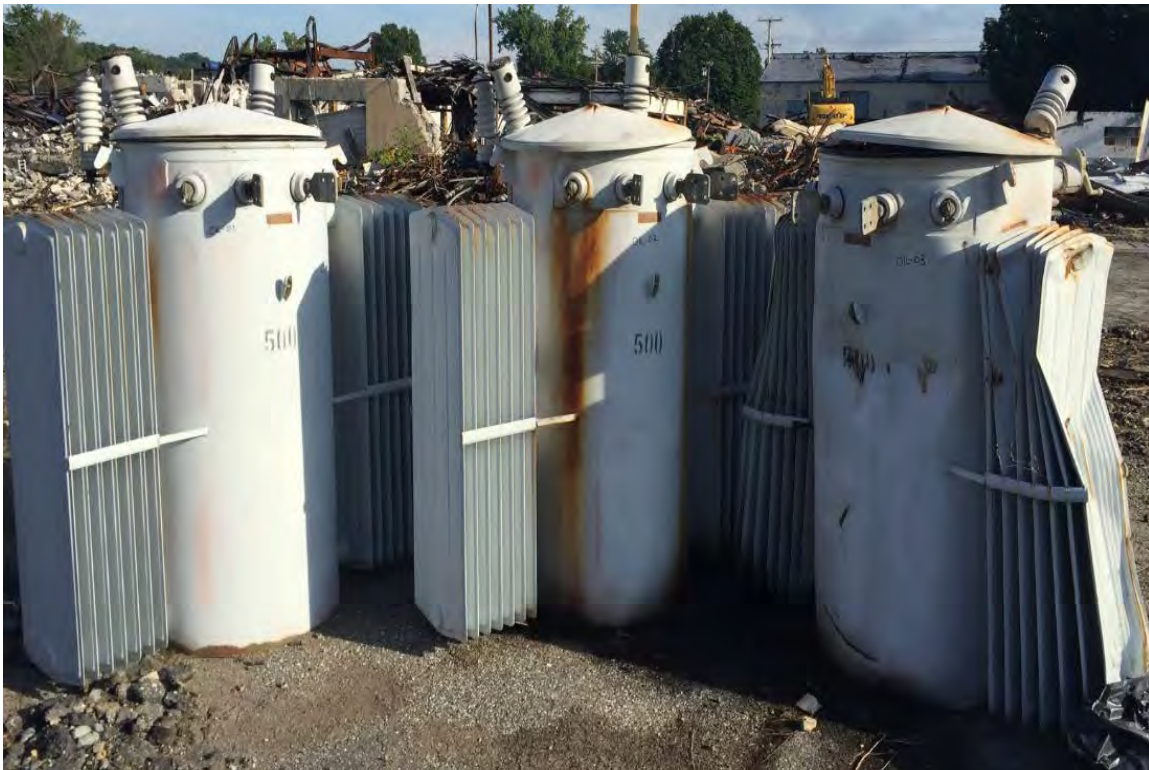
SCENE: View of the three transformers to be drained and transported off site for disposal. Photograph taken facing north.

On 20 September 2016, two personnel from Cyn Environmental were on site to pump oil out of the three transformers located adjacent to the southern fence line. ERRS assisted with loading the drained units onto a trailer for transport and disposal (see Appendix C, Table 1). On 21 September 2016, OSC Jarrell, RM Overend, and START member Burton performed a site walk to inspect the work areas, and discussed plans for grading areas when building walls were demolished.

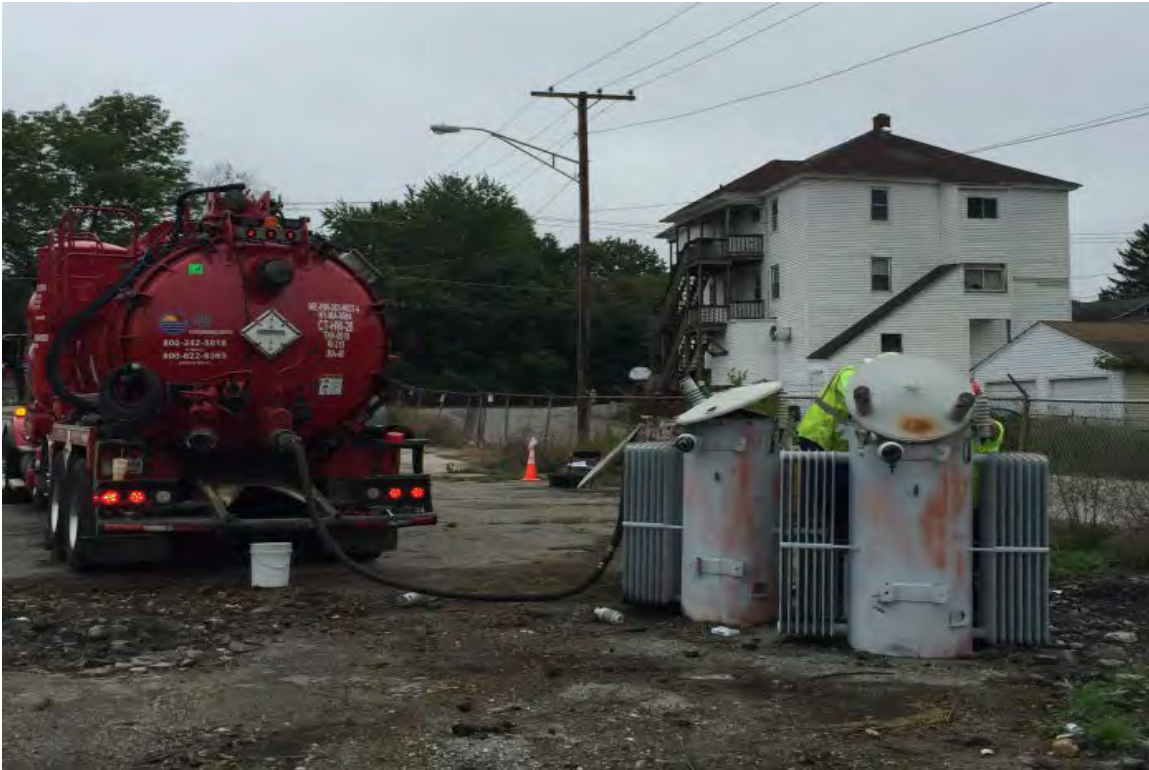
SCENE: View of Cyn Environmental pumping the oil from the transformers. Photograph taken facing east.

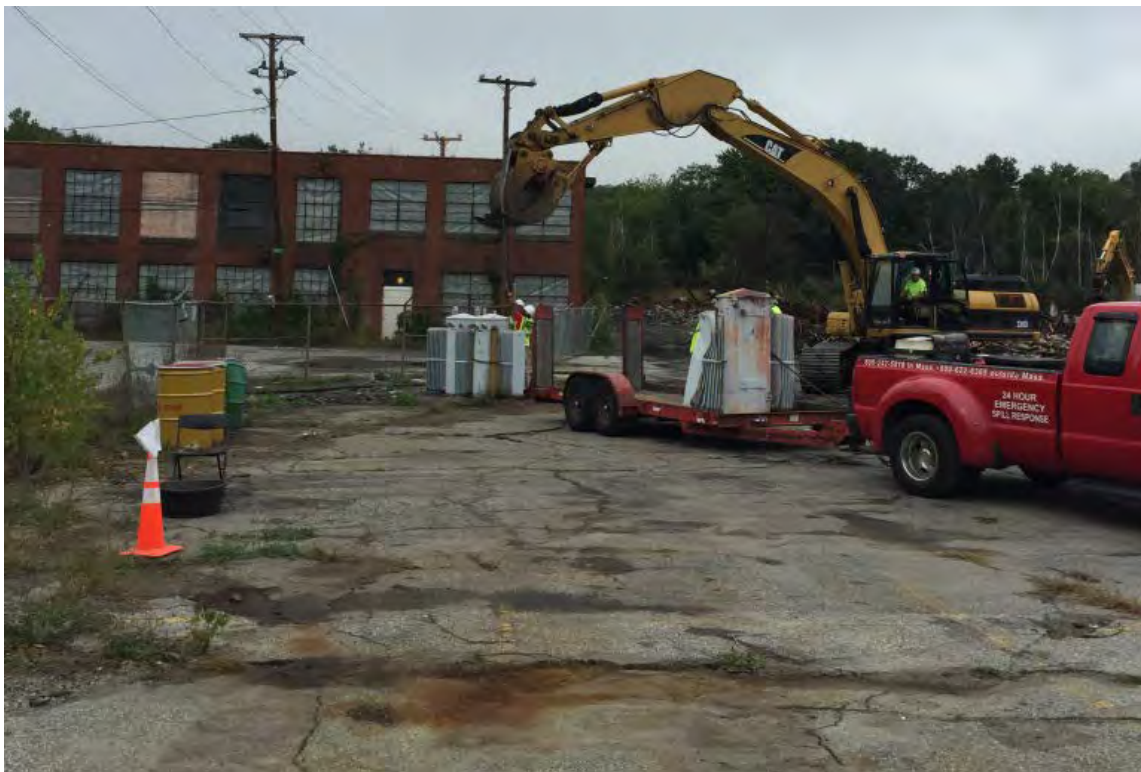
SCENE: View of overpack drums containing miscellaneous flammable liquids and the excavator loading empty transformers onto the Cyn Environmental flatbed trailer for disposal. Photograph taken facing west.

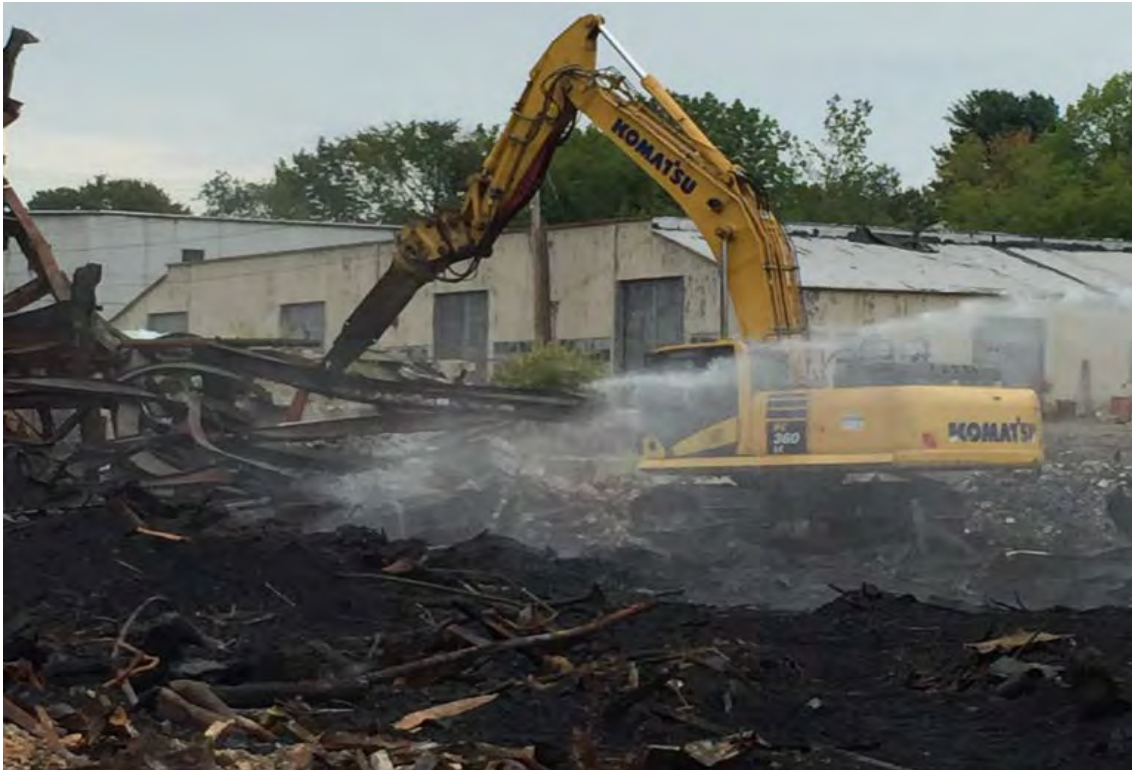
SCENE: View of steel shearing in the west central building footprint while using water for dust suppression. Photograph taken facing northeast.

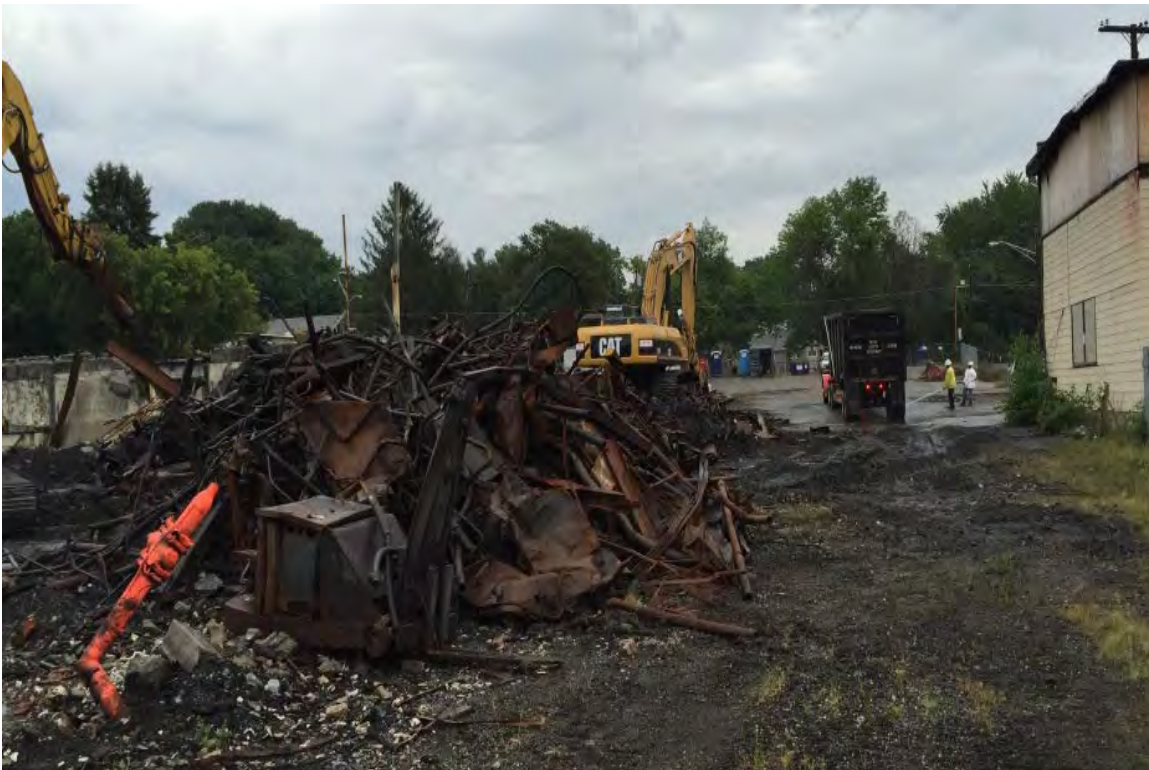
SCENE: View of ongoing steel shearing, steel load out, dust suppression, and truck tire decontamination. Photograph taken facing east.

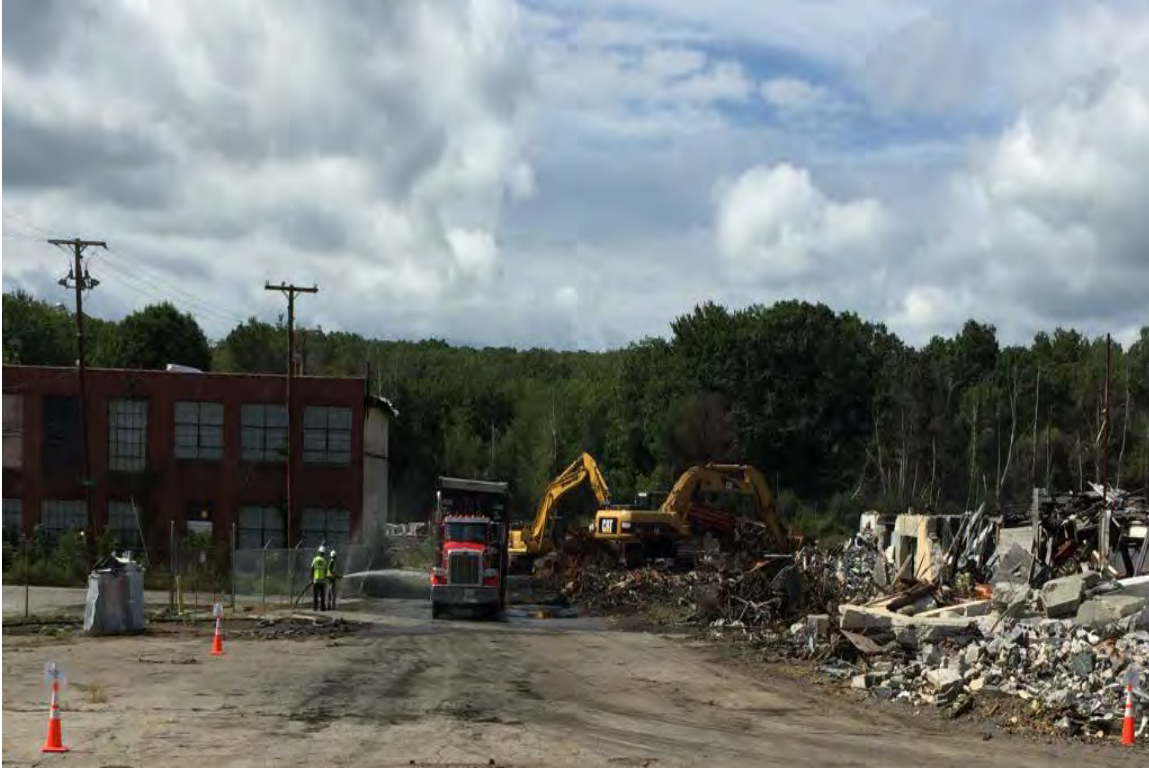
SCENE: View of ongoing steel shearing, steel load out, dust suppression, and truck tire decontamination. Photograph taken facing west.

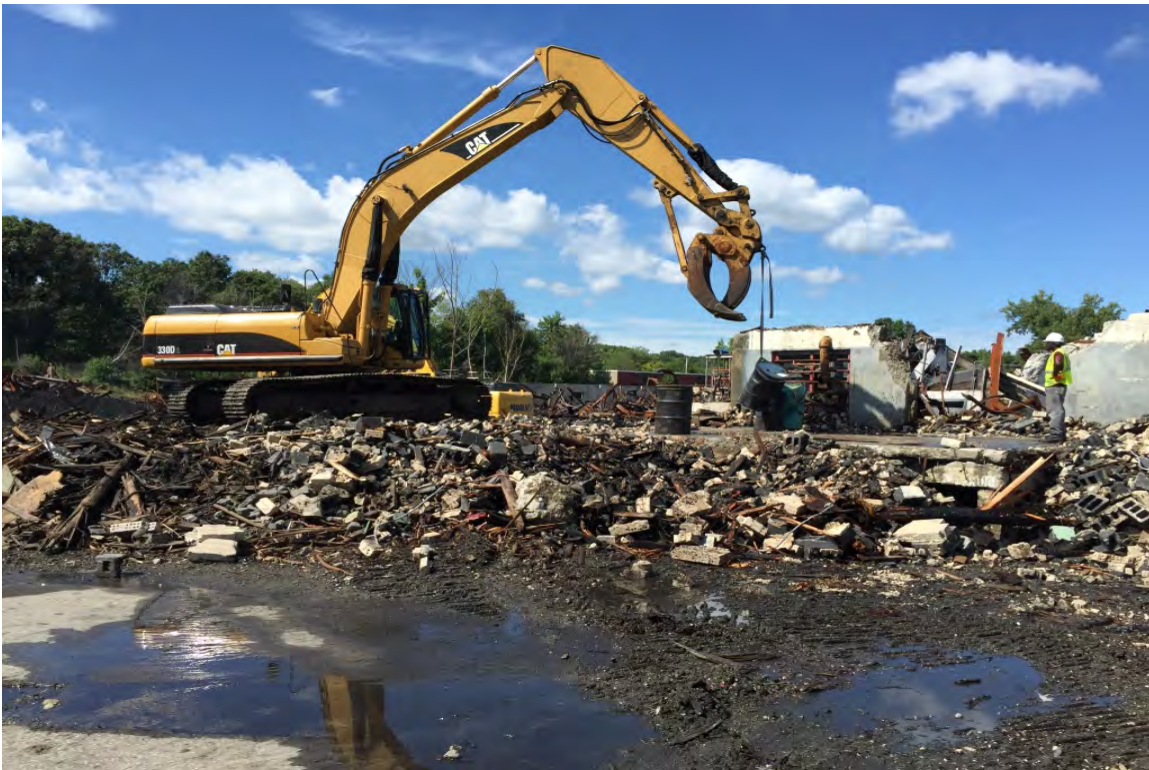
SCENE: View of ER personnel staging drums on a pad for overpacking. Photograph taken facing northwest.

On 9 September 2016, the ERRS crew uncovered three drums under debris. One drum was damaged that contained miscellaneous small containers and showed a photoionization detector (PID) reading of 20 parts per million (ppm). The drums would be staged on the building footprint and overpacked.

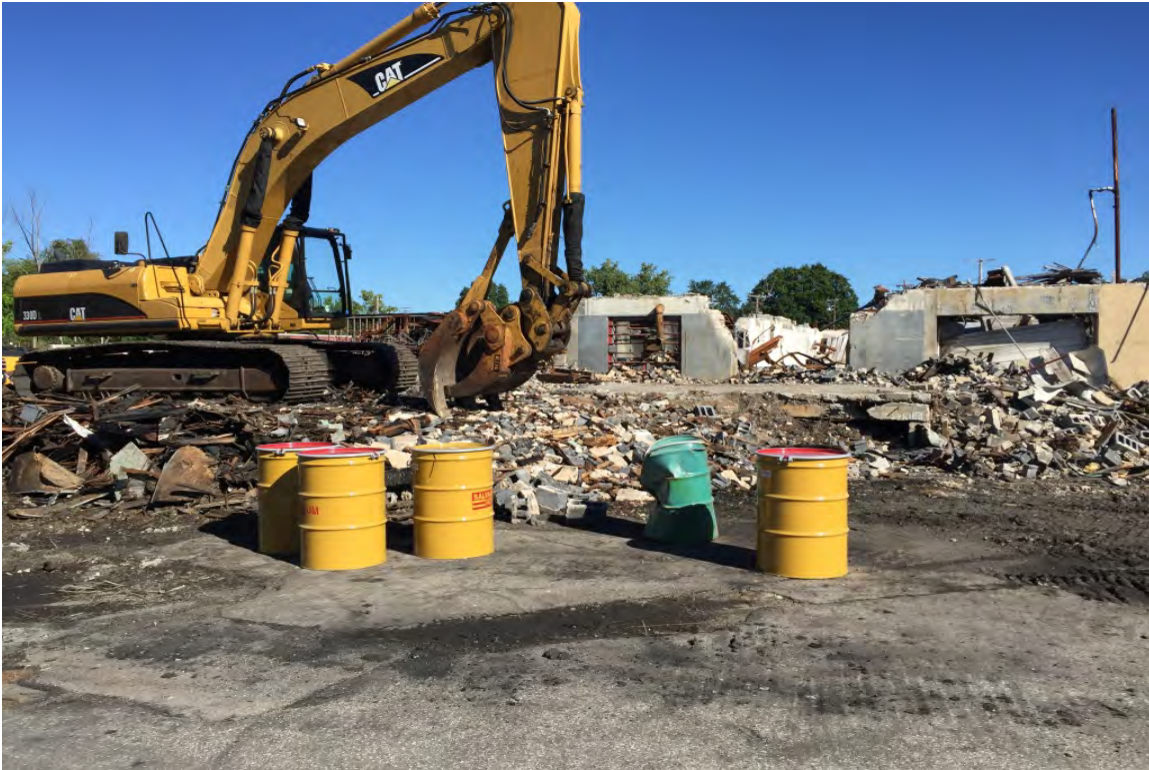
SCENE: View of ER personnel overpacking drums. Drums were staged along the southern fence line. Photograph taken facing north.

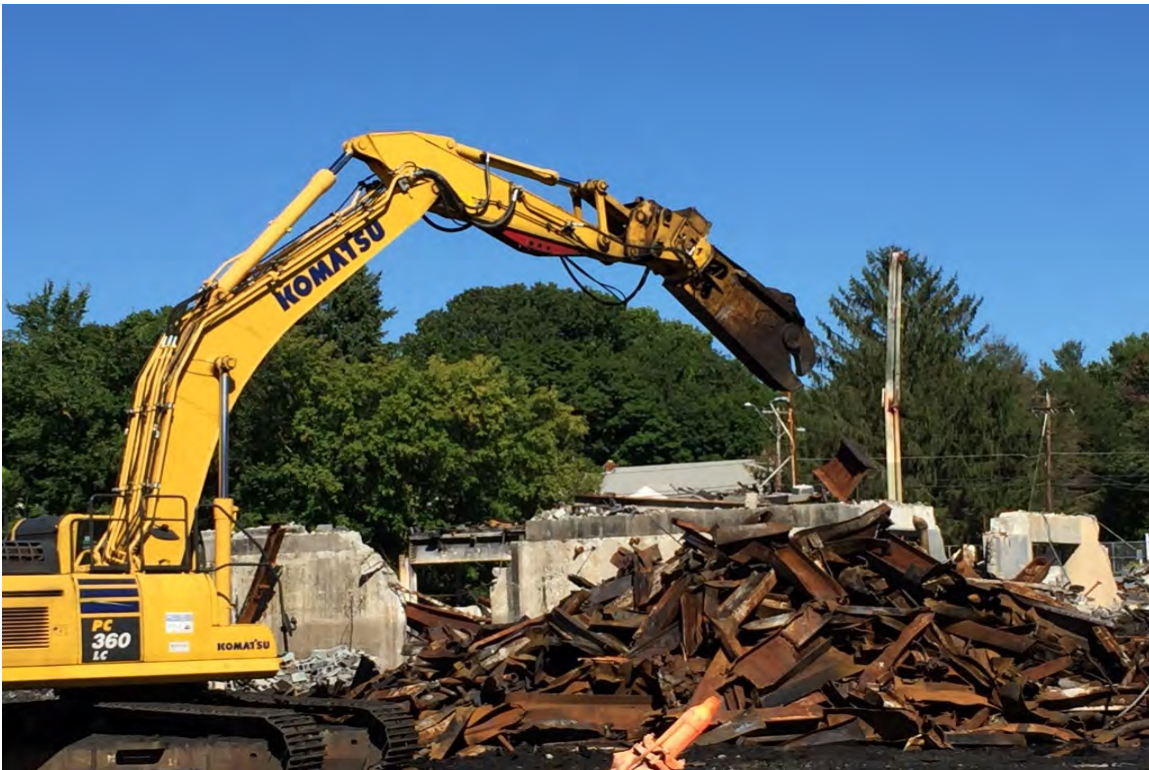
SCENE: View of steel shearing activities. Photograph taken facing northeast.

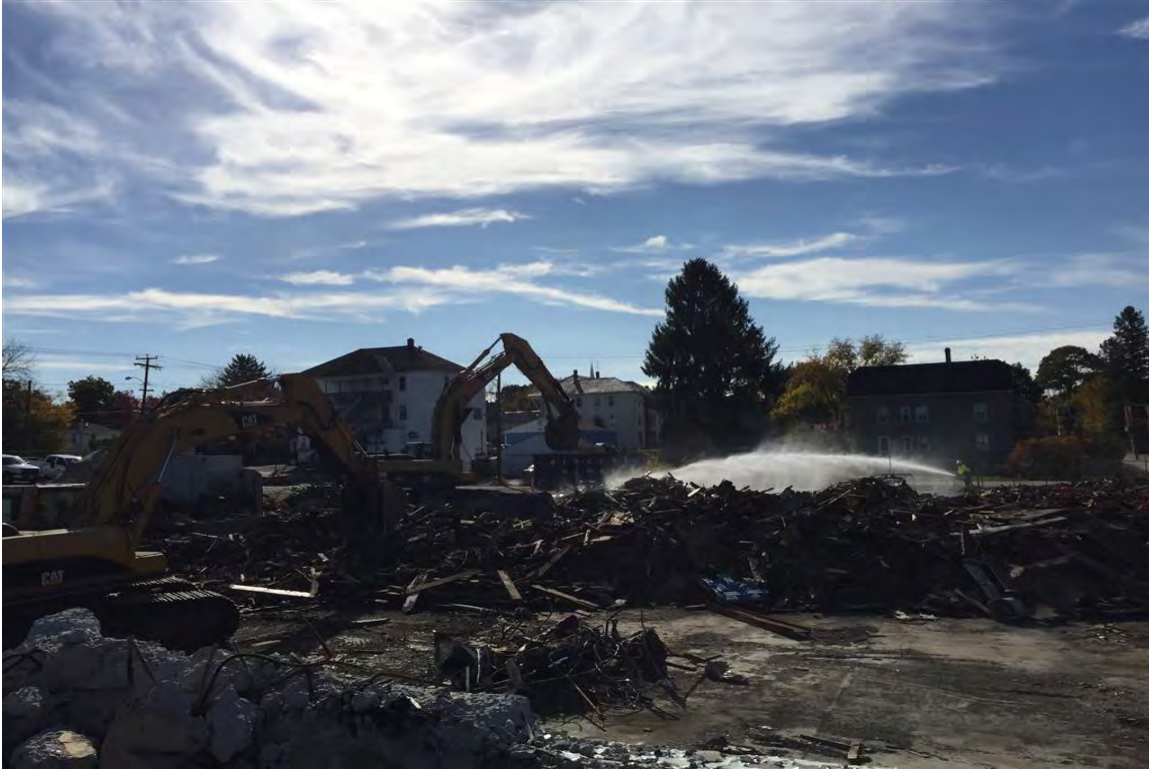
SCENE: View of steel load out, steel decontamination, dust suppression, and continued steel consolidation. Photograph taken facing south.

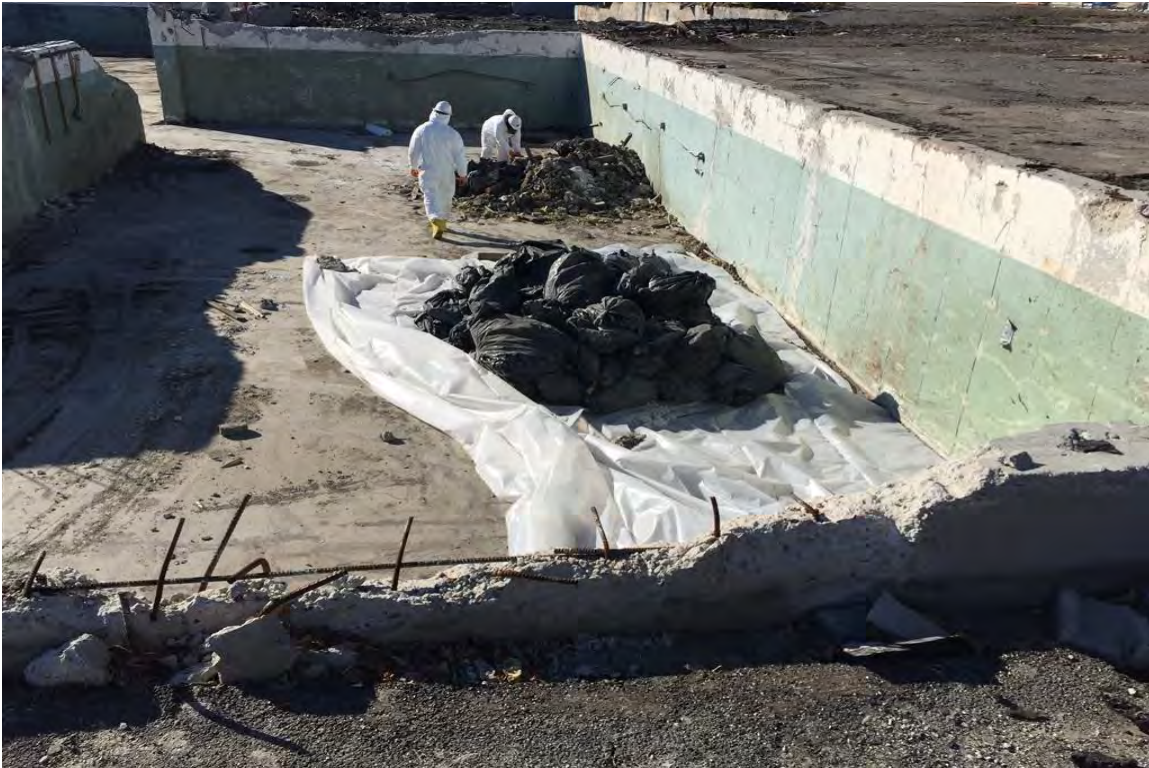
SCENE: View of suspected bags of Asbestos-Containing Material (ACM) being secured on polyethylene (poly) sheeting until load out. Photograph taken facing west.

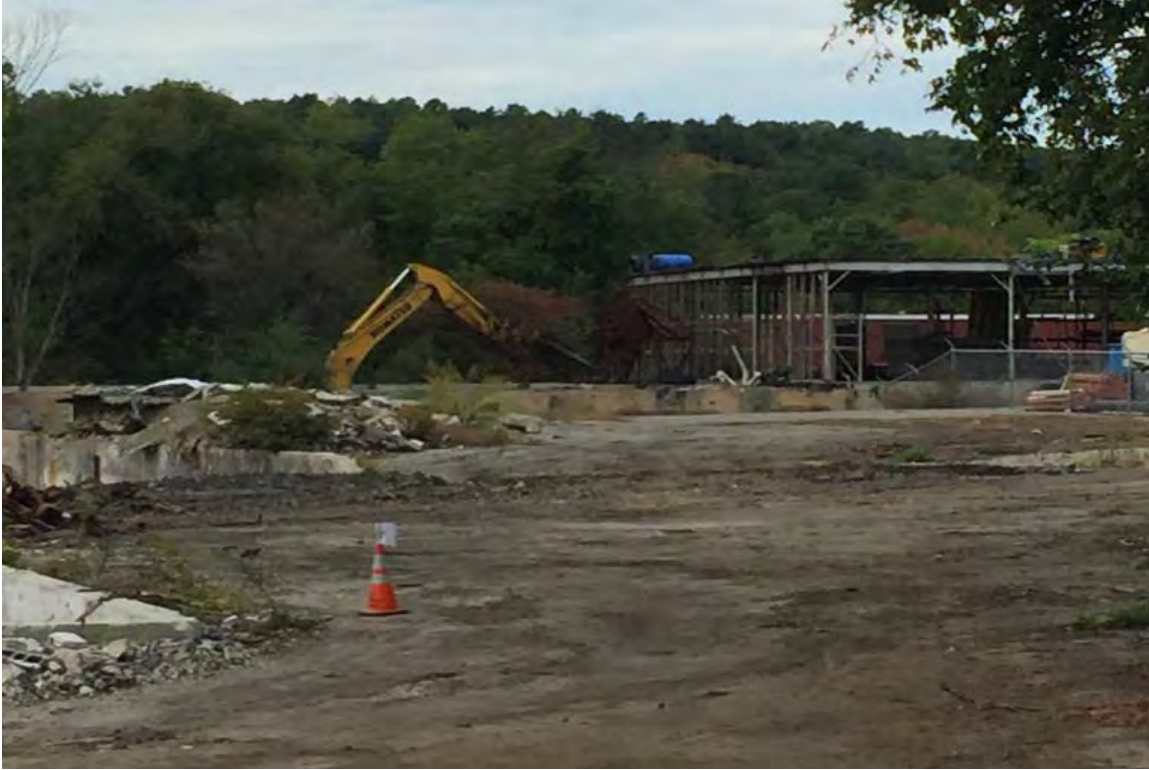
SCENE: View of the steel staircase adjacent to the abutters building being sheared. Photograph taken facing northwest.

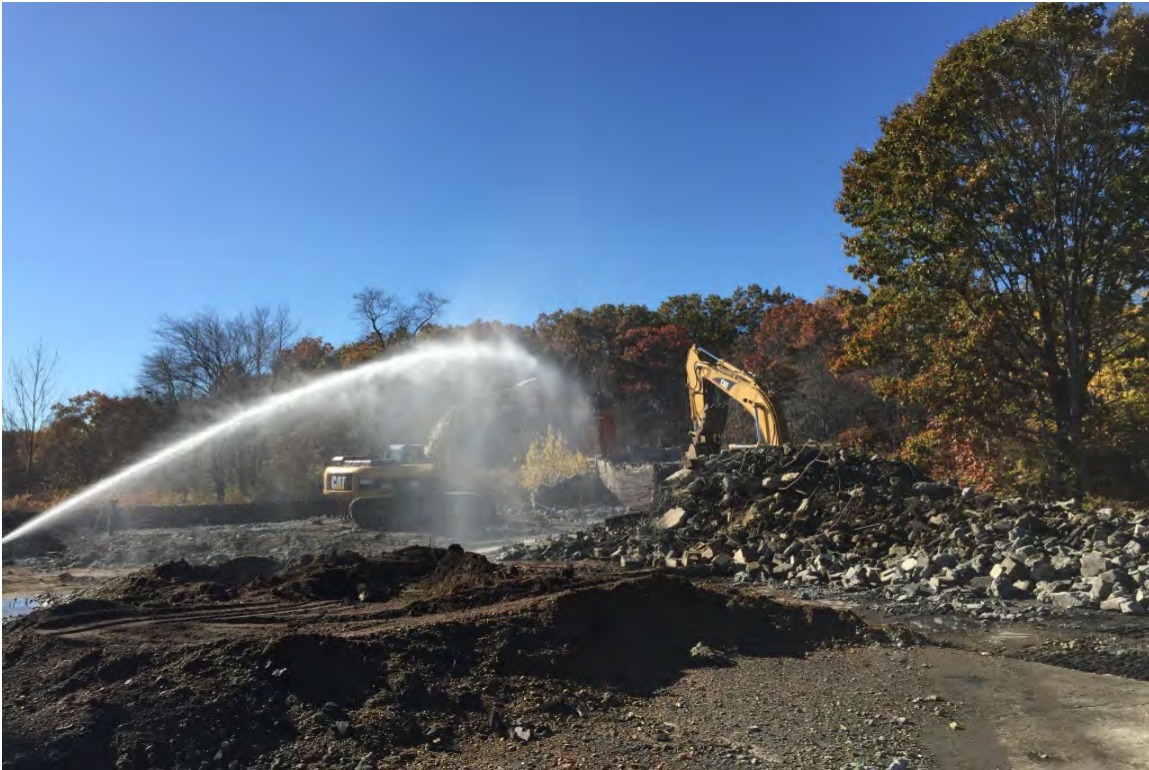
SCENE: View of the demolition of the Wastewater Treatment Plant (WWTP) adjacent to the French River. Demolition activities were performed using town water for dust suppression. Photograph taken facing south.

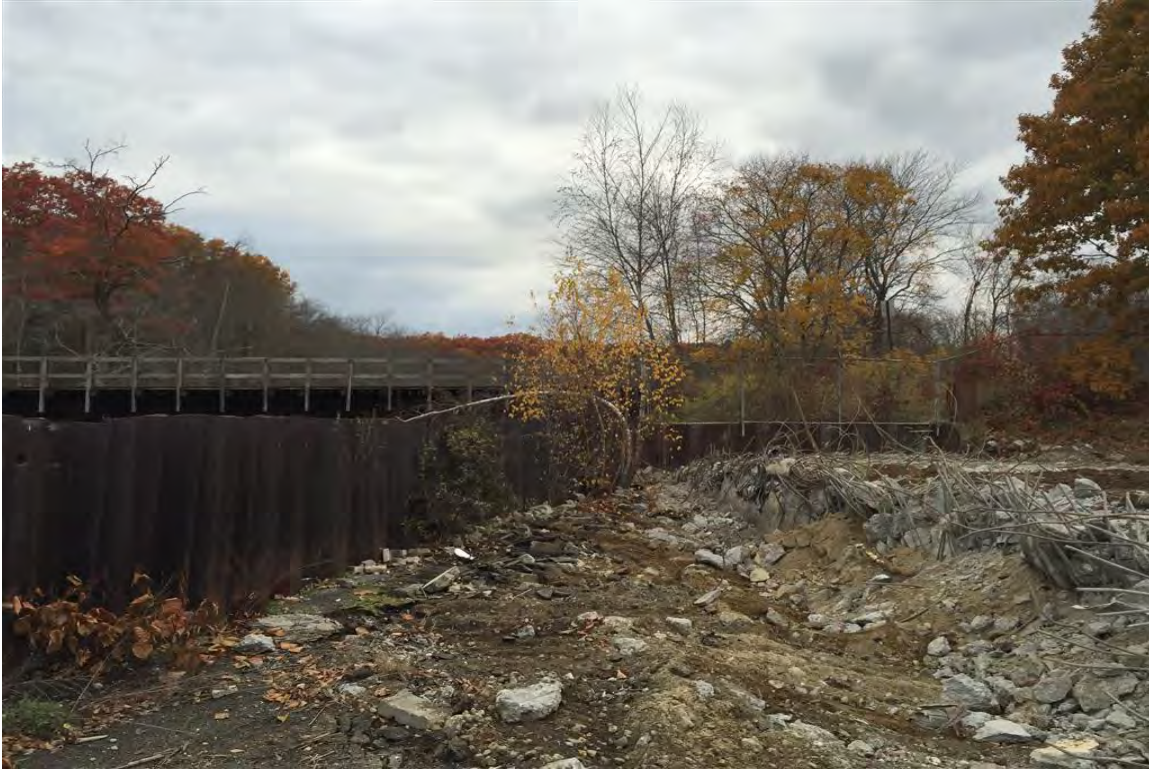
SCENE: View of the demolished WWTP adjacent to the French River. Photograph taken facing west.

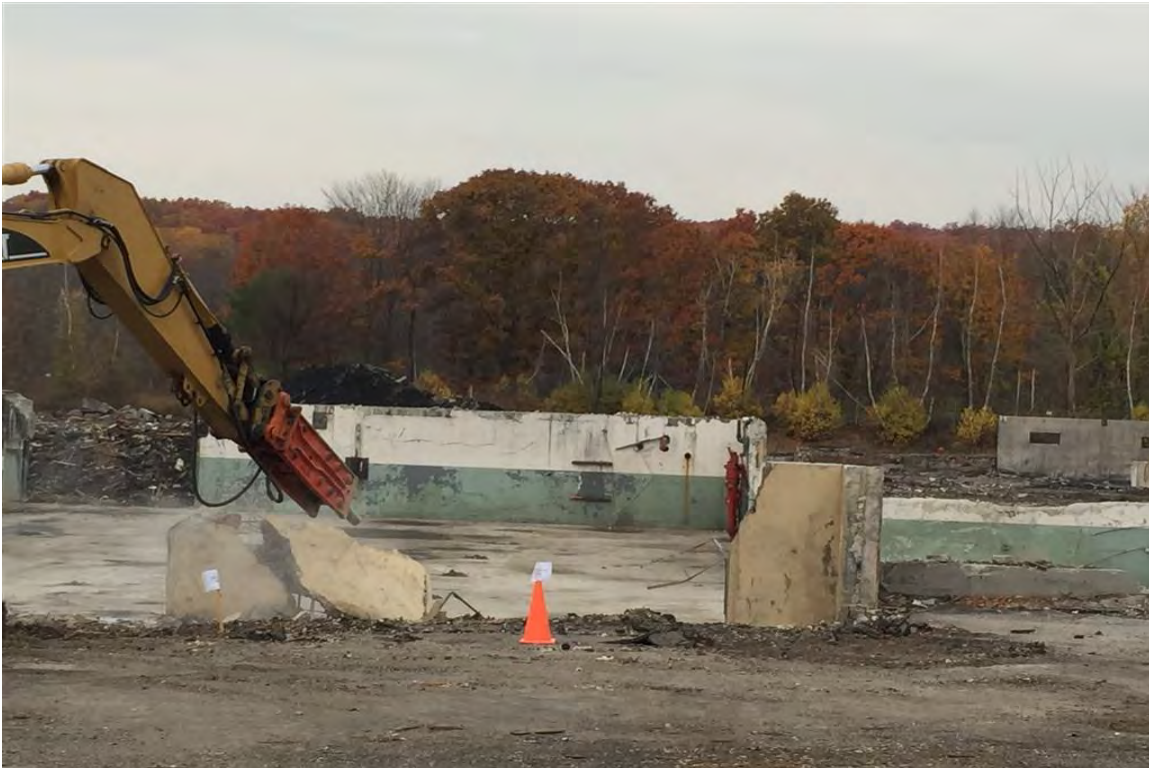
SCENE: View of the Hydraulic Hammer (Hoe Ram) breaking the concrete wall to-grade along the eastern wall of the Anglo Enterprises building. Photograph taken facing west.

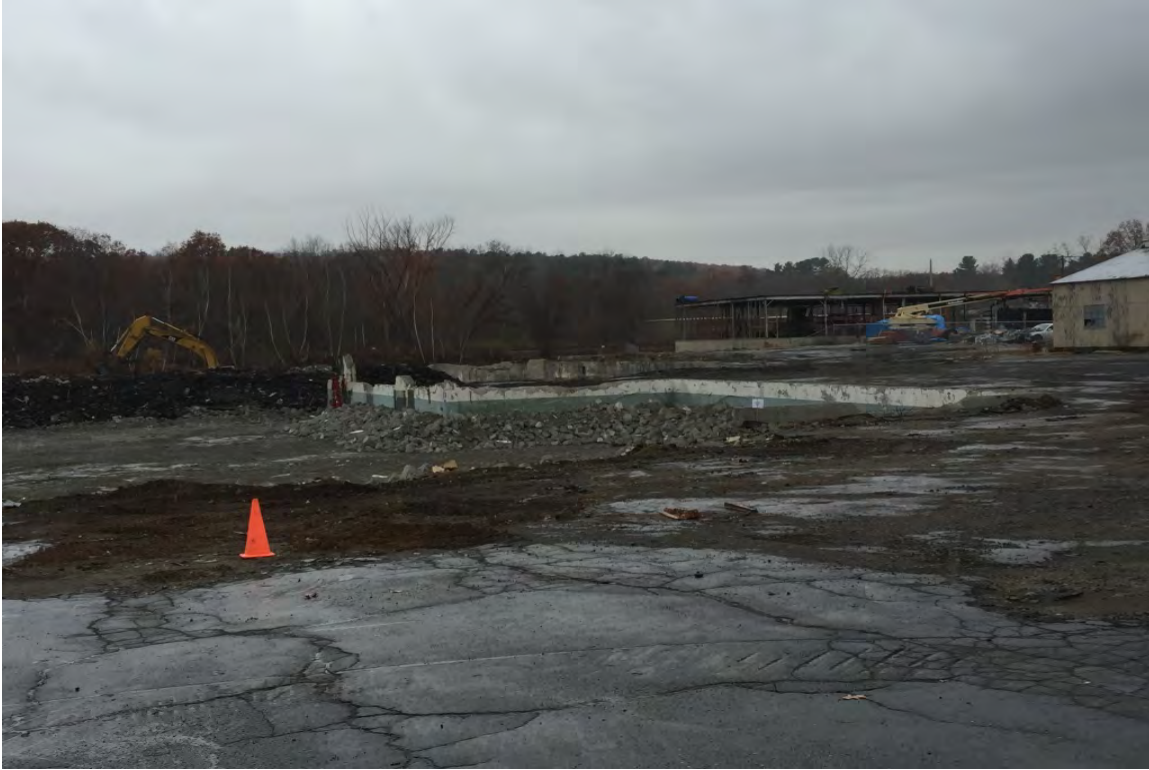
SCENE: View of the demolished walls and ACM debris stockpile prior to winter shutdown. Photograph taken facing northwest.

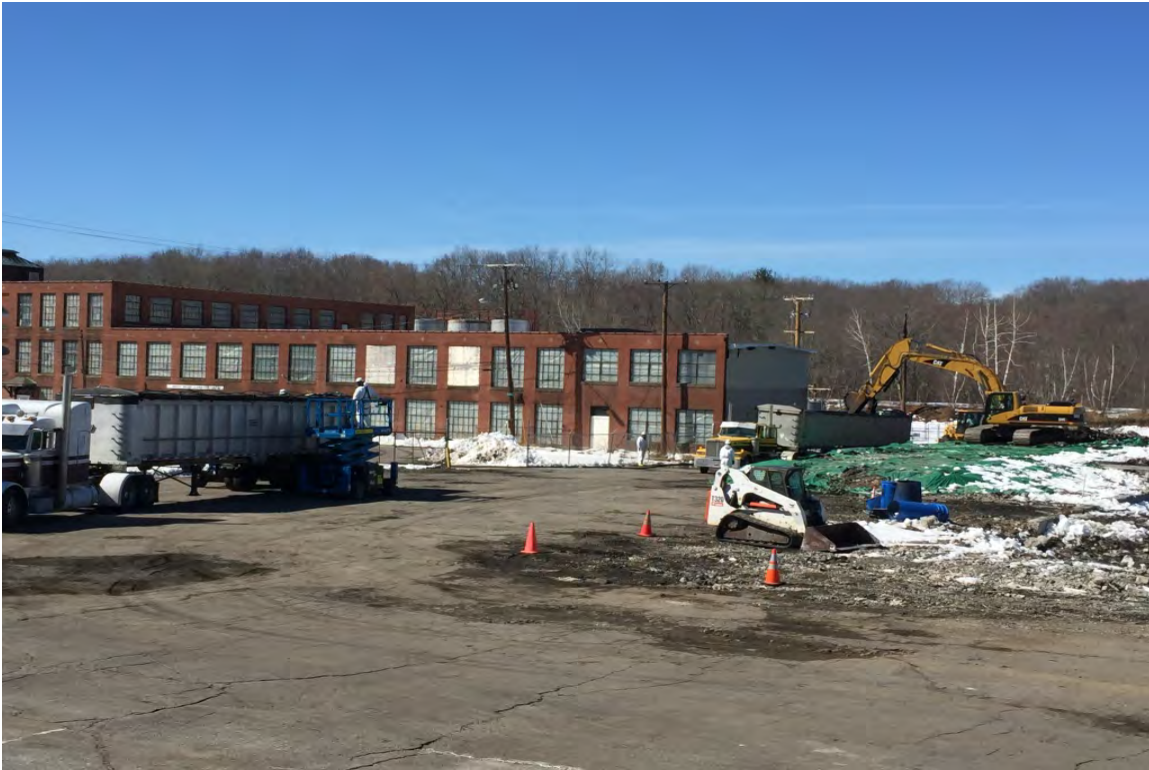
SCENE: View of a trailer being double lined with 10 mil poly sheeting, while another trailer is being loaded with ACM debris. Photograph taken facing southwest.

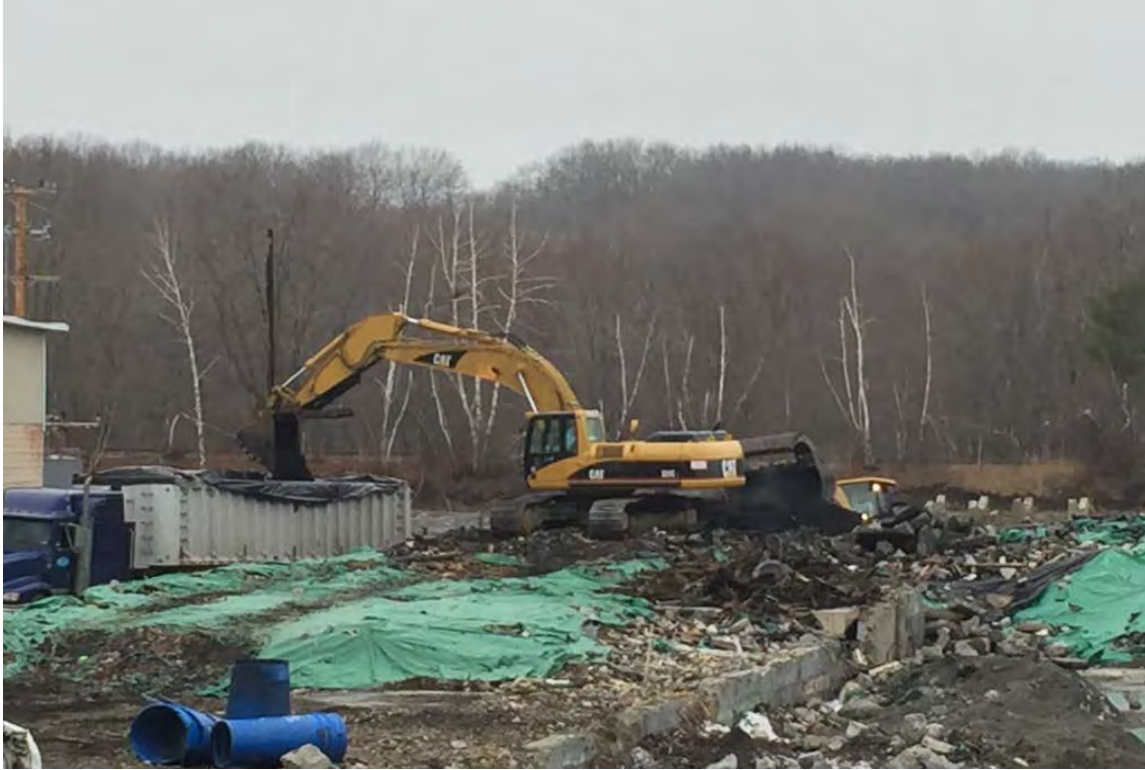
SCENE: View of a trailer being loaded while a front-end loader replenishes the load-out pile. Photograph taken facing west.

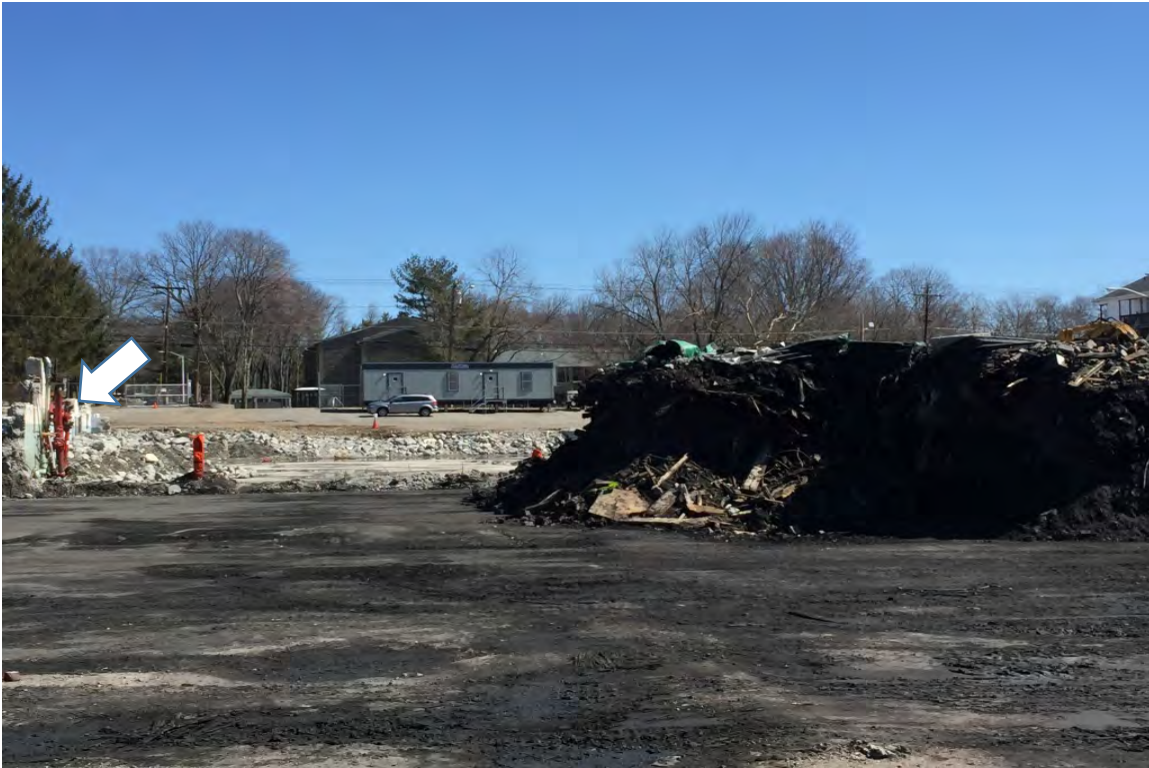
SCENE: View of progress while loading out ACM debris from the stockpile. The stockpile was originally even with the two taller sewer pipes on the left (see arrow). Photograph taken facing east.

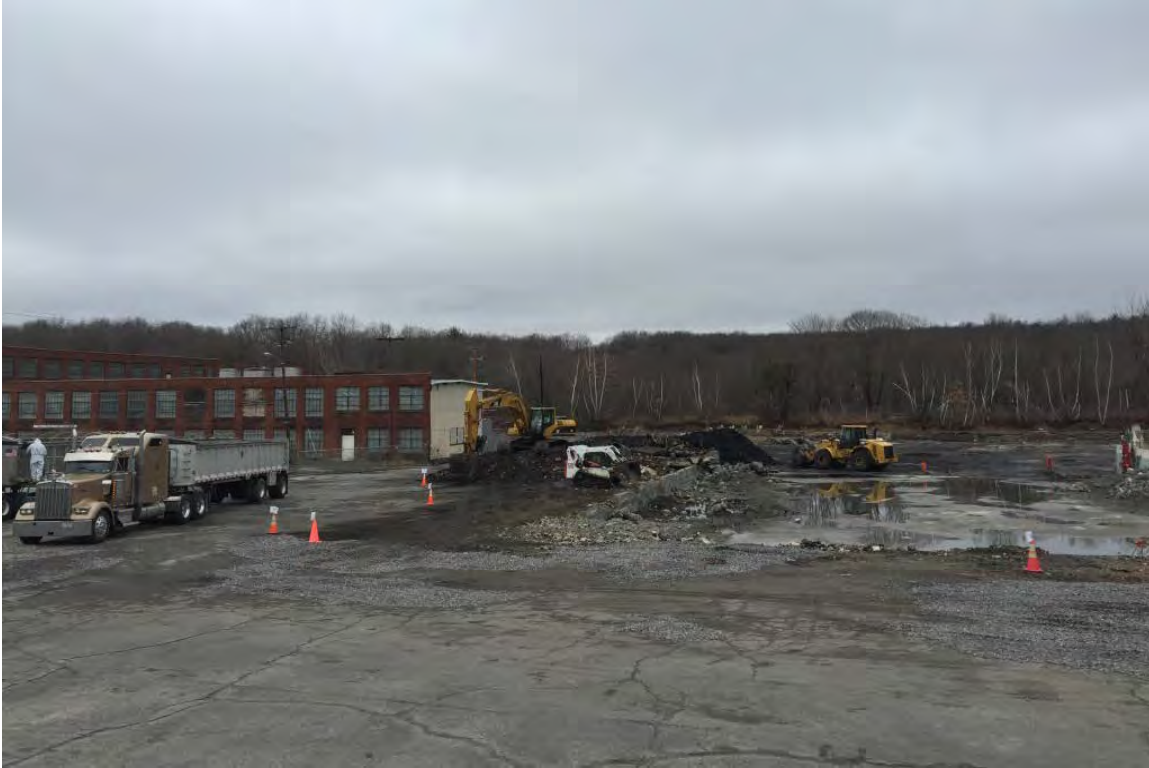
SCENE: View of a trailer being lined with poly sheeting and the front-end loader moving debris into the load-out area. Photograph taken facing west.
